**Post-Treatment Assessment
for Aquatic Plant Control
ERDC Demonstration Project
Tonawanda Creek/Erie Canal**

Contract No. W912P4-10-D-0002

December 2014

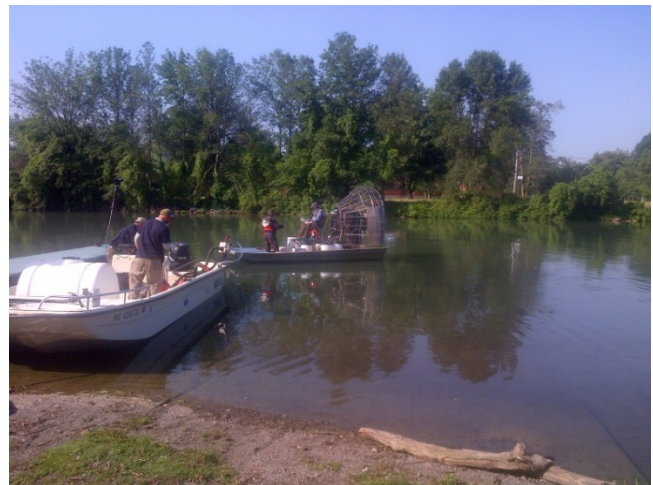
First applicator boat following transfer of herbicide, City of North Tonawanda Service Drive Boat Launch

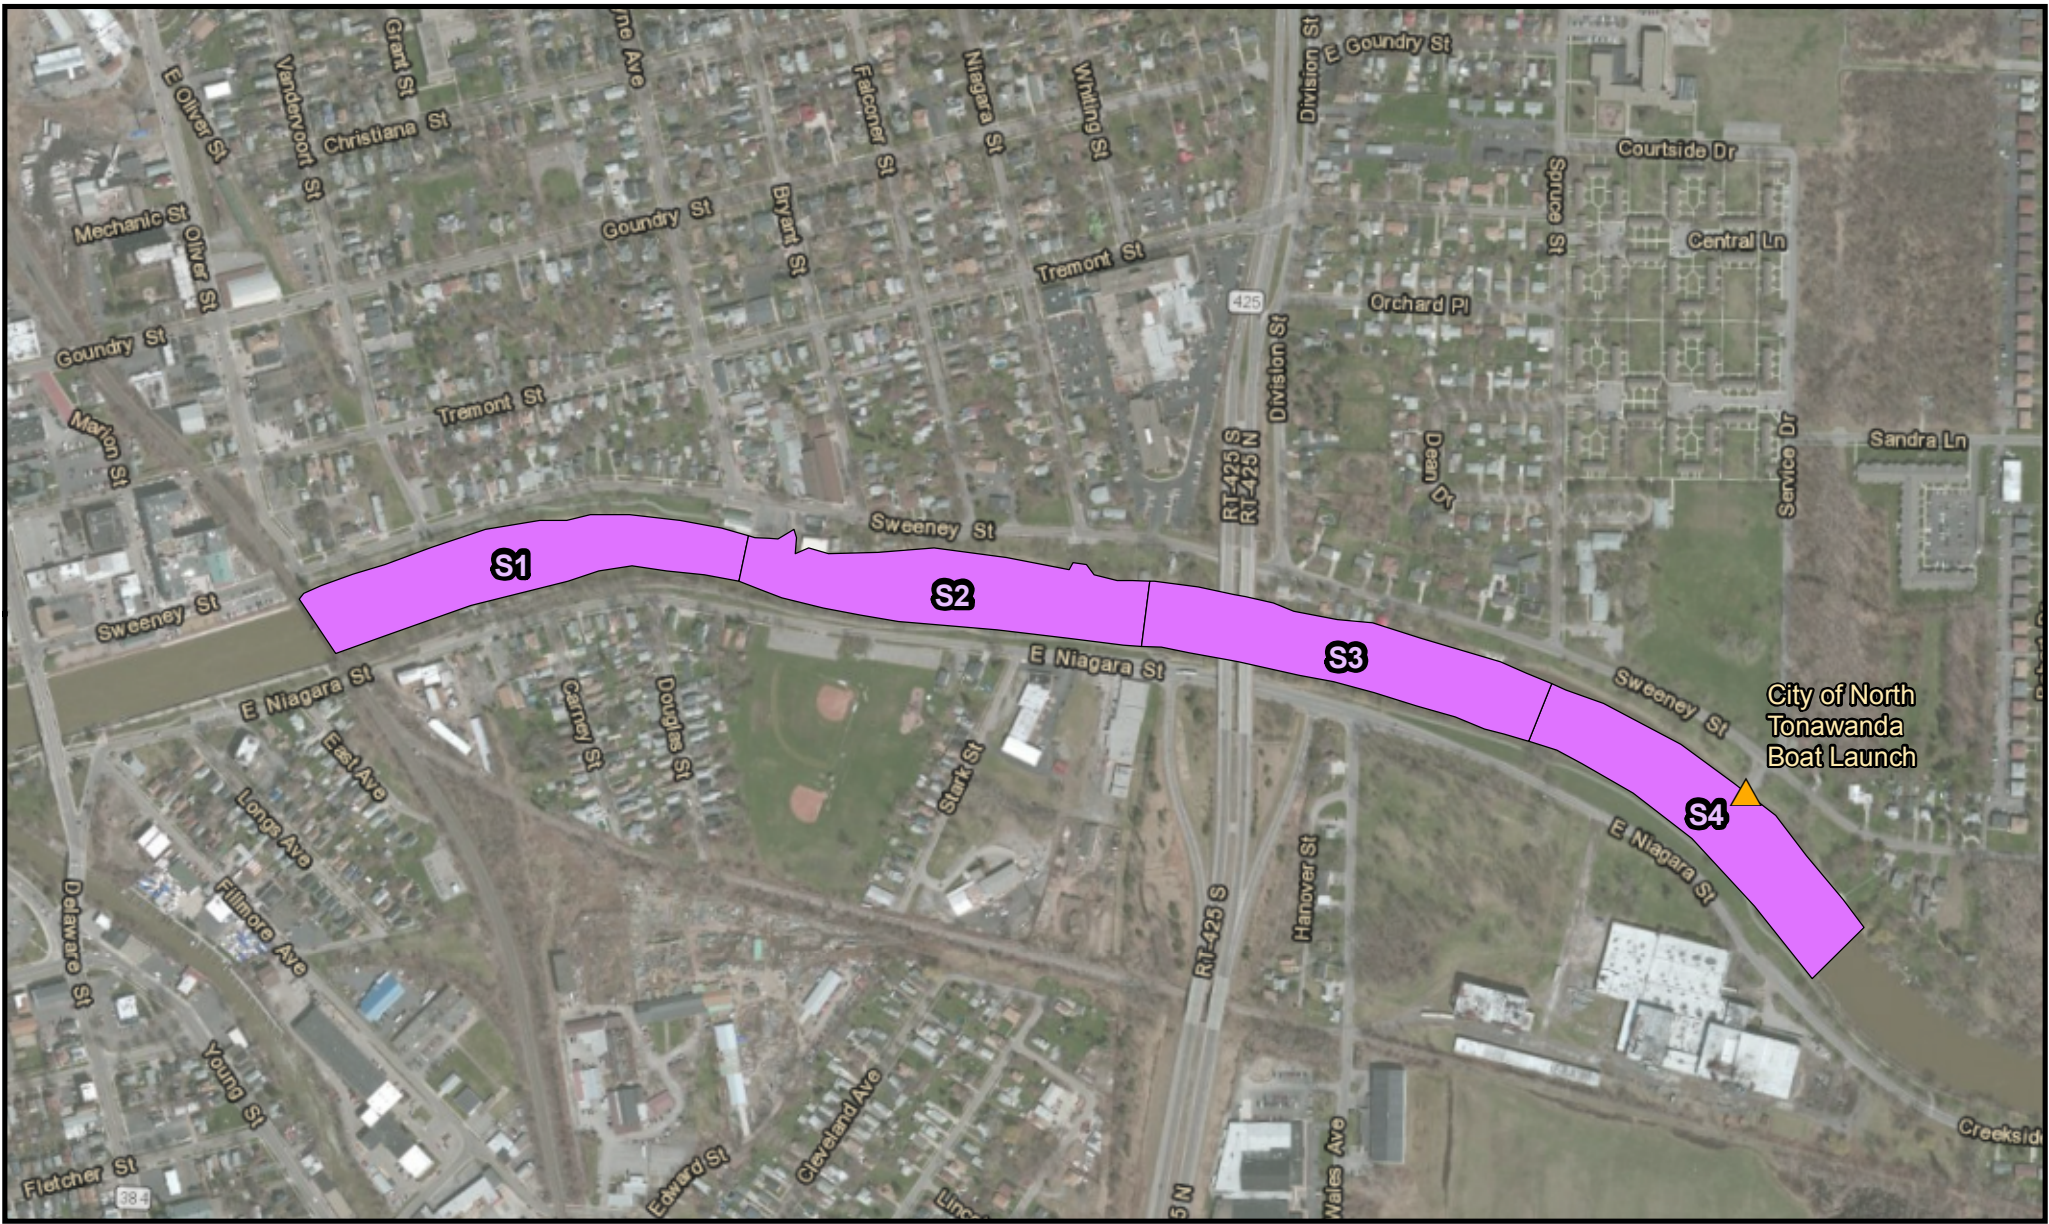
City of North
Tonawanda
Boat Launch

Tonawanda Creek

Although the herbicide was applied to the near-shore areas, rapid lateral movement of the herbicide was noted within hours of application. Endothall concentrations at sampling sites TRT1 and TRT2 within the treatment area were significantly lower by 5 and 21 hours post-treatment (see Table 2-9). Sampling location TRT3 at the east end of the treatment area maintained endothall concentrations near the target rate throughout 21 hours post-application (Netherland 2014b). During the post-treatment application, flows were shut down for slightly more than 24 hours (see Section 2.7.3.5 below). Following resumption of normal flows in the canal, rapid loss of herbicide from the treatment area and significant dilution of the herbicide concentrations in downstream locations east of the treatment area were noted (see Table 2-9, 27-hours post-application).
